Switch protection using the top of rail friction modifier system

The work described in the following article was carried out using **KELTRACK® top of rail friction modifier system**.

This article will focus on WN572A at Nuneaton Cemetery Junction; a switch where the life was significantly less than expected due to the fatigue failure of the switch blade approximately 2m from the switch tip. The half switch was replaced every 18 months after three defect weld repairs at significant cost. The objective was to seek a solution, using observations made at Barnt Green.

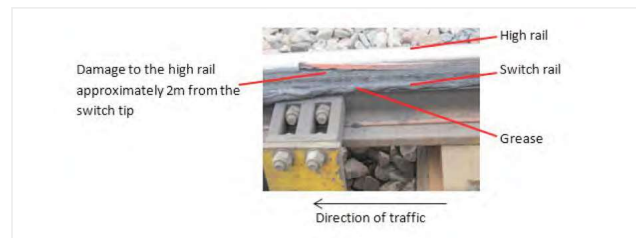
Figure 5: WN572A switch blade damage

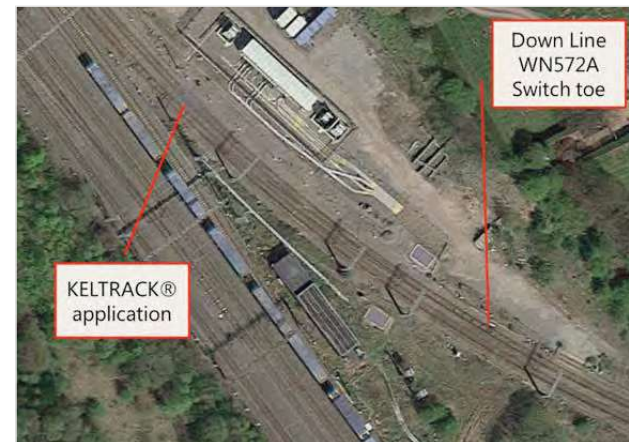
Figure 8: The friction modifier installation site and switch location

In February 2013 when the friction modifier system was installed at Nuneaton, there had been a half set replacement of the switch some three months earlier in November 2012. The system that was installed was positioned to ensure that the friction modifiers covered the approach to WN572A so the steering of the wheelsets was optimised through the whole switch (see figure 8). The installation also took into account the positions of signals and signalling equipment and was positioned to ensure that the filling of the equipment could be done without going trackside. It was important that the friction modification and lubrication were considered as a system – both components are required to minimise the wear to the switch.
